UPDATE

Spring, 1990

Bowater, Alabama Pine Join User Group

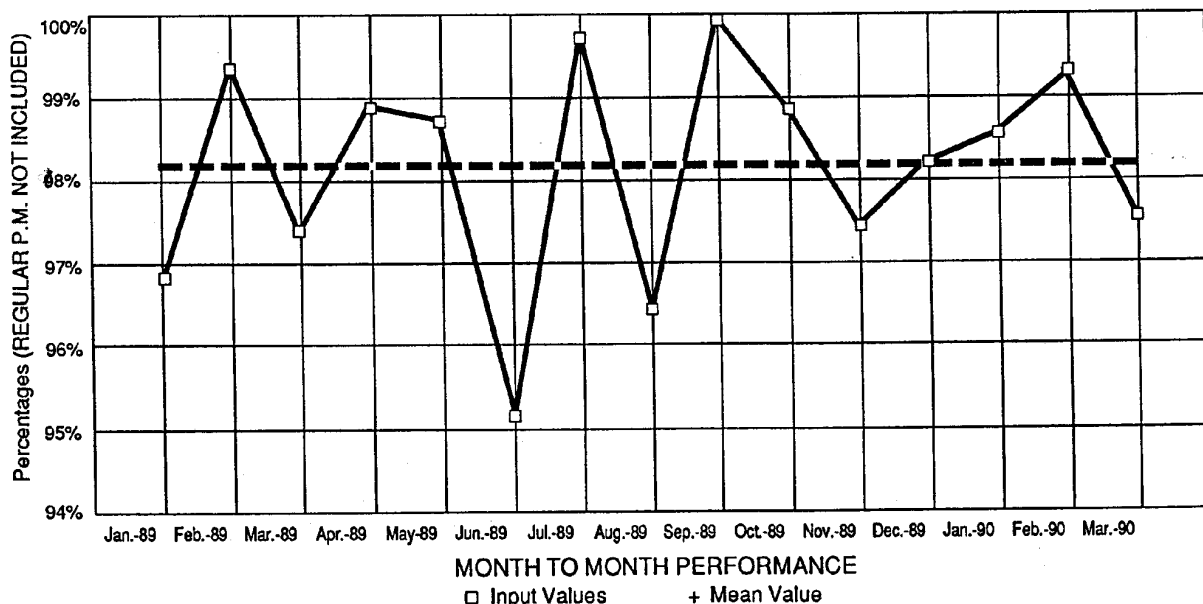
P&H Portal Crane Availability

The following chart shows the P&H Portal Crane availability for E.B. Eddy at Nairn Center, Ontario. This crane is a 30 ton straight track portal with P&H AC static stepless control on hoist bridge and trolley installed in 1982.

(Statistics courtesy of E.B. Eddy FP)
